**TRANSPORTATION SCIENCES CENTER
ACCIDENT RESEARCH GROUP**

CALSPAN REMOTE AIR BAG DEPLOYMENT INVESTIGATION

CALSPAN CASE NO. 93-7

VEHICLE - 1993 VOLVO 850 GLT

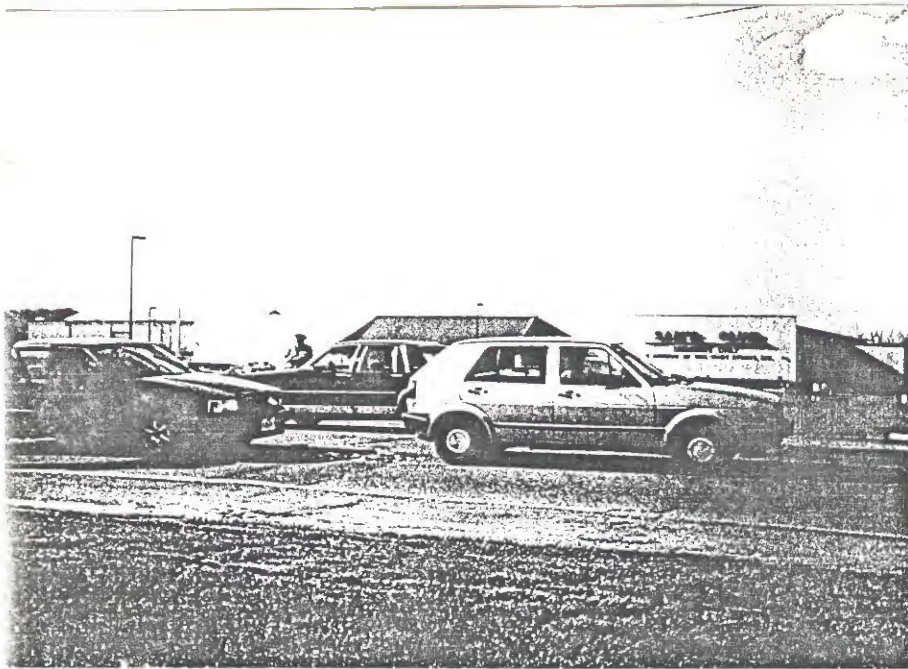
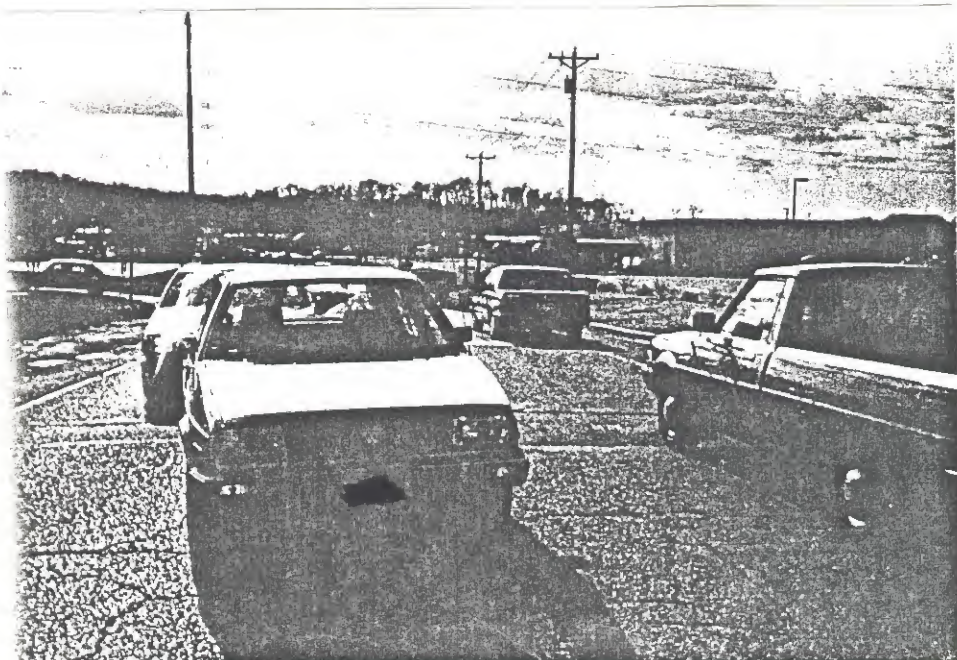
Final Rest Positions of the Involved Vehicles

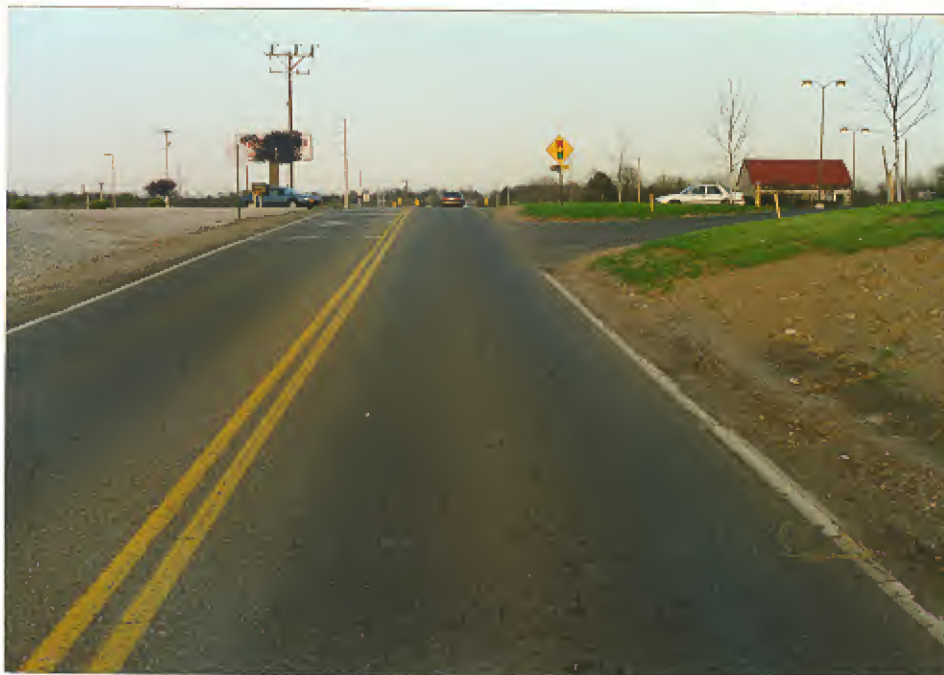
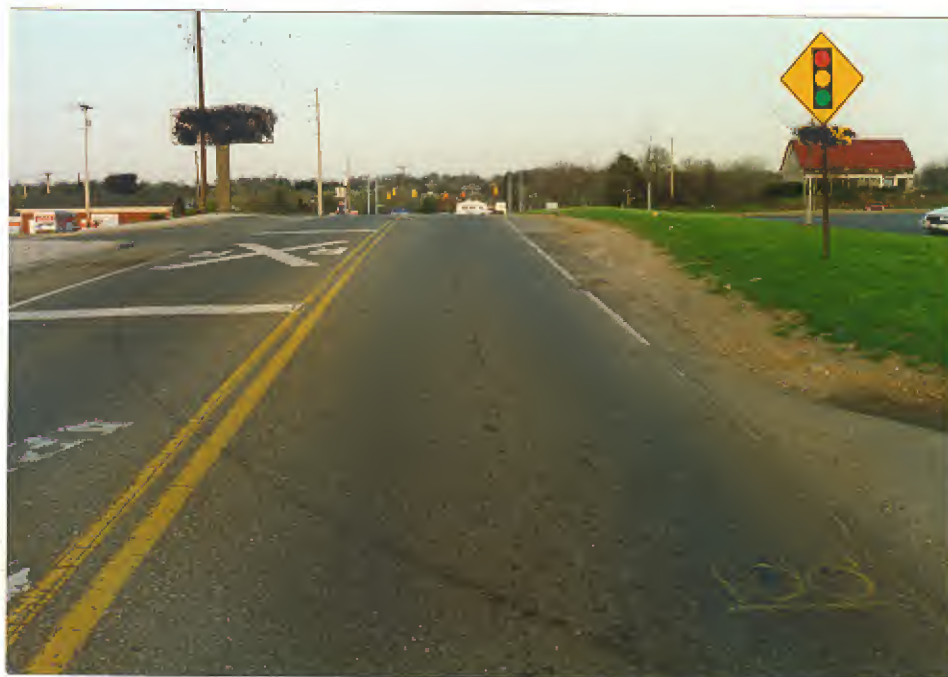
Pre-Crash Trajectory of the Volvo 850 GLT

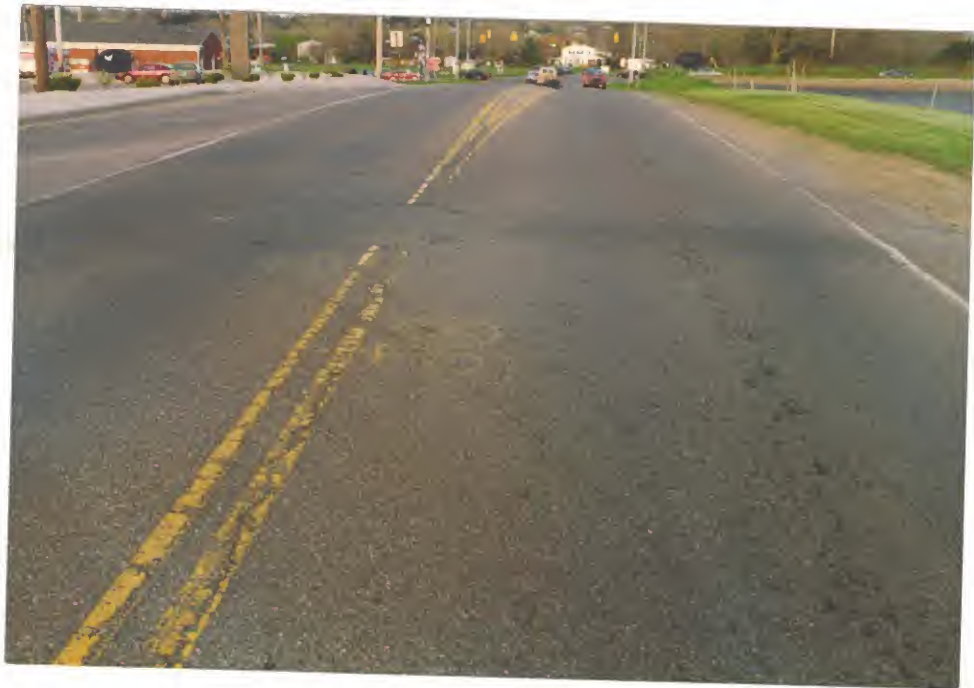
5

Point of Impact

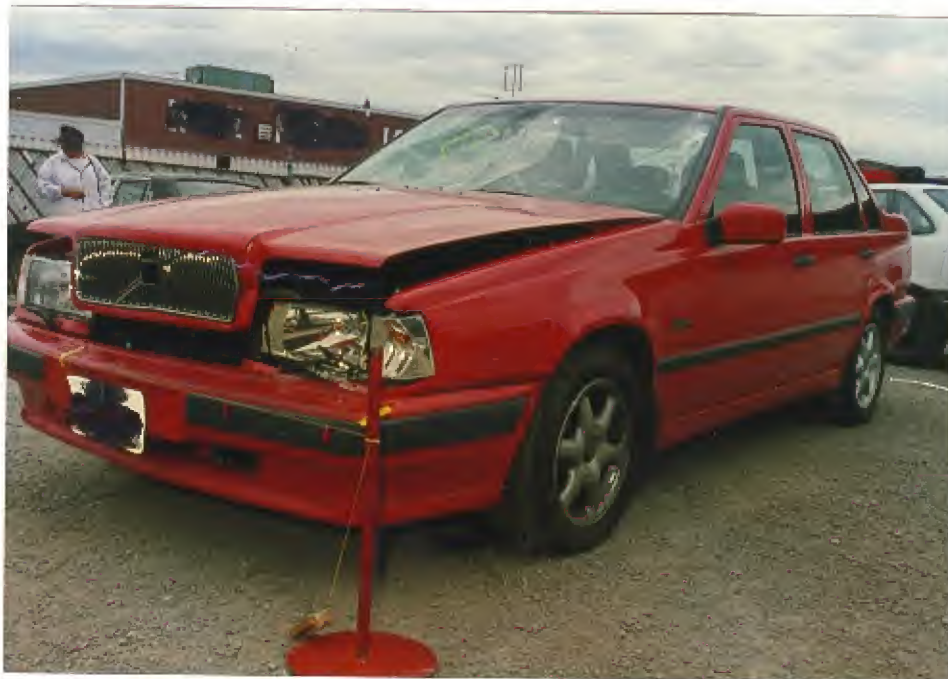
10

Left Front Three-Quarter View

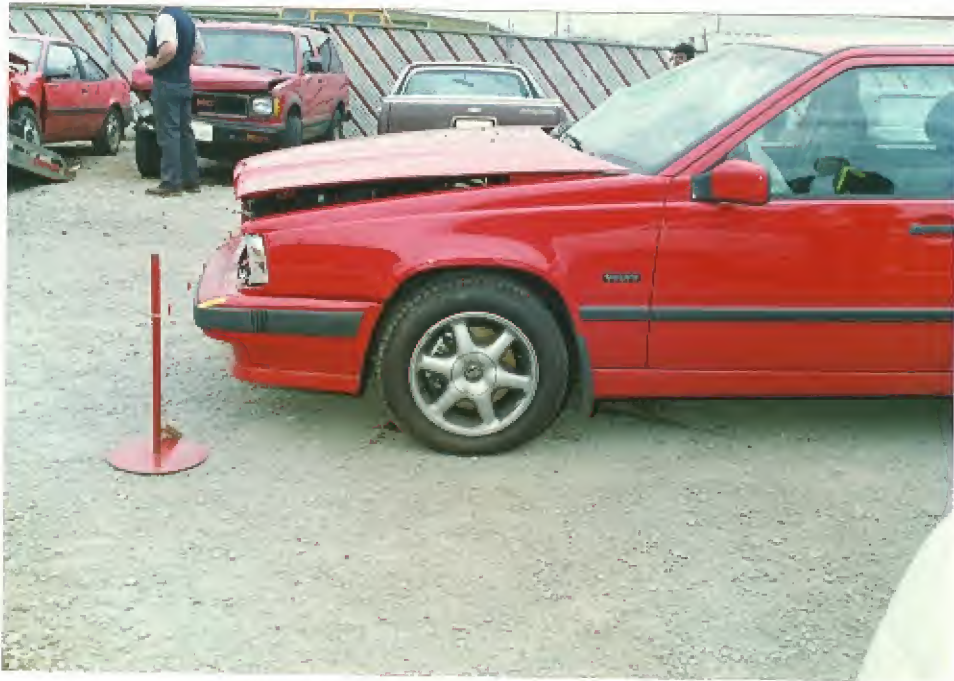
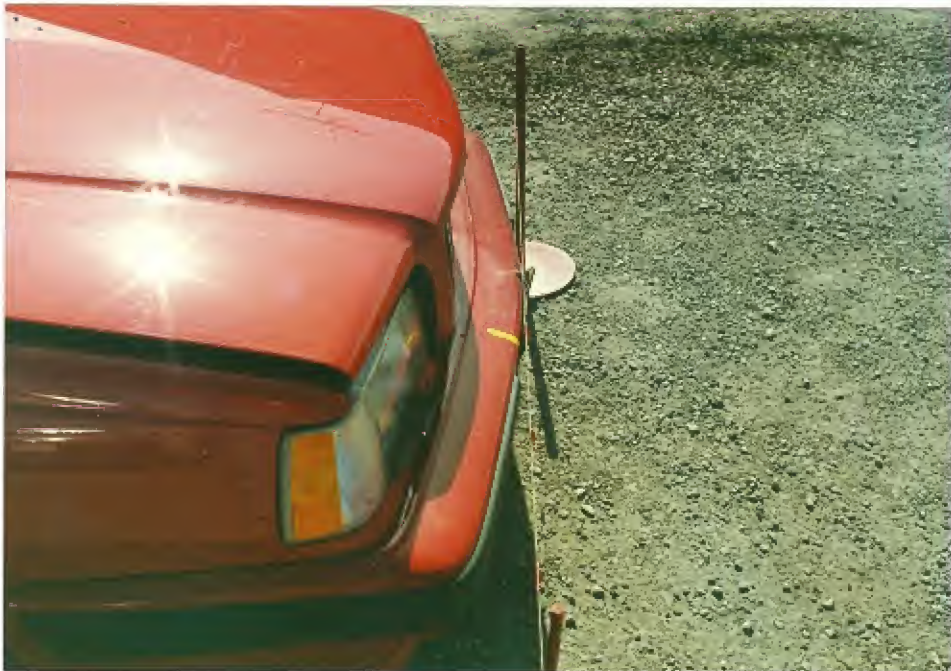
Perpendicular Views Showing the Extent of Crush to the Volvo

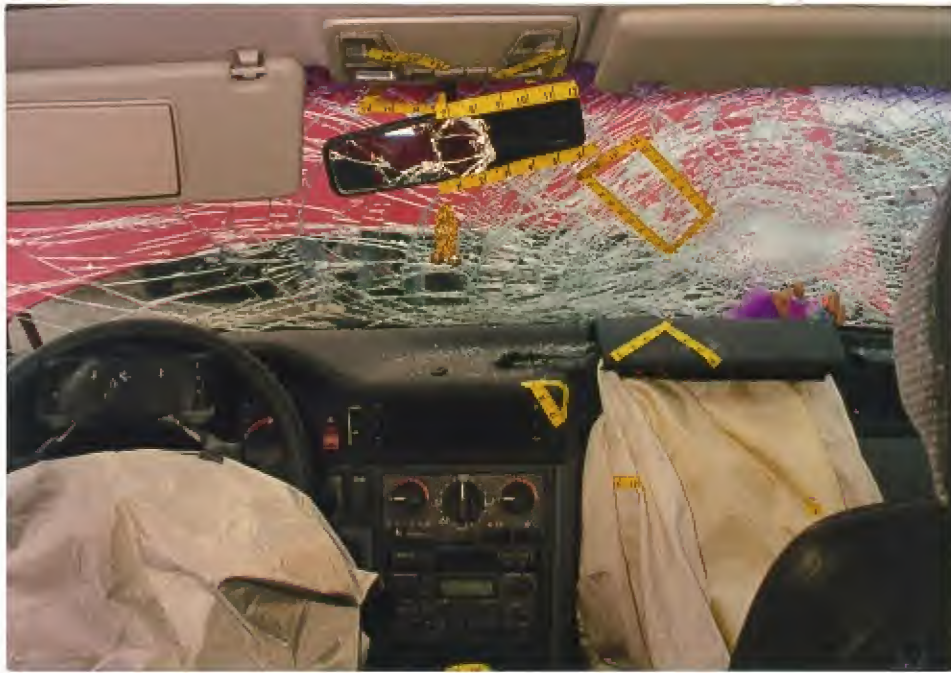
17

Overall Interior View of the Deployed Dual Air Bags and Subsequent Occupant Contact Points

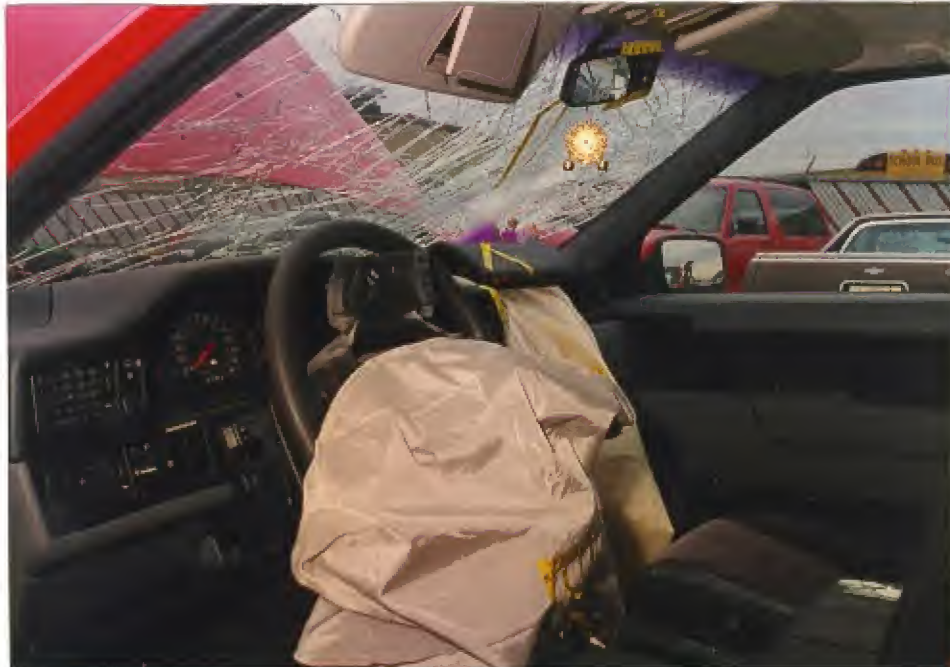
18

Deployed Driver's Side Air Bag

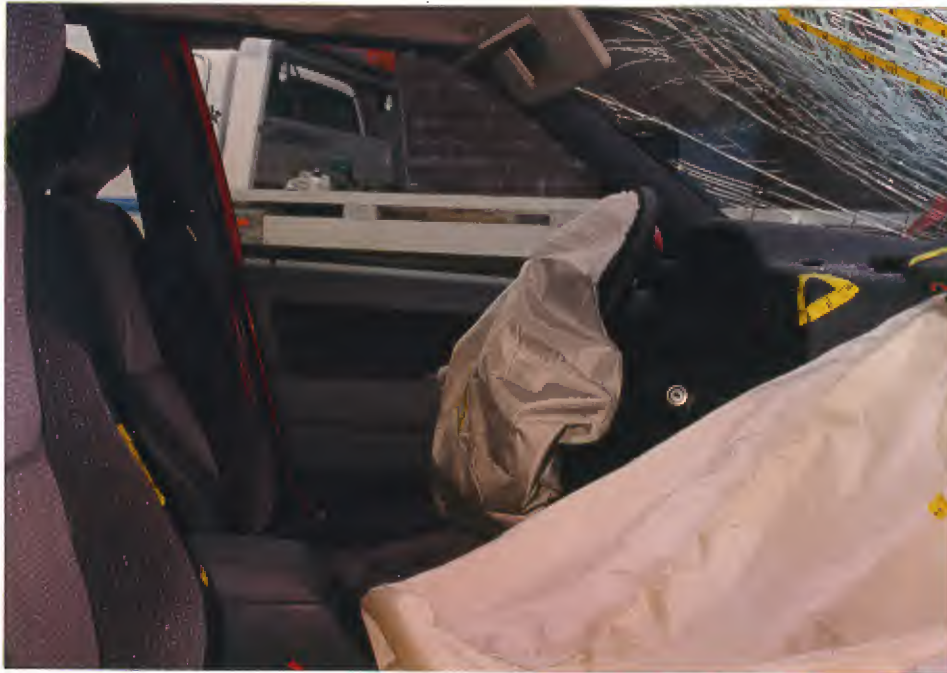
19

Although the driver was not wearing the manual belt system, the deployed air bag prevented her from direct contact with the steering assembly, thus preventing her from further injury. There were no other contact points noted within the vehicle from the driver. She remained upright and probably rebounded into the left front seat back, where she came to rest.

Perpendicular View of the Deployed Driver's Side Air Bag
and Fully Retracted and Locked Manual 3-Point Belt System

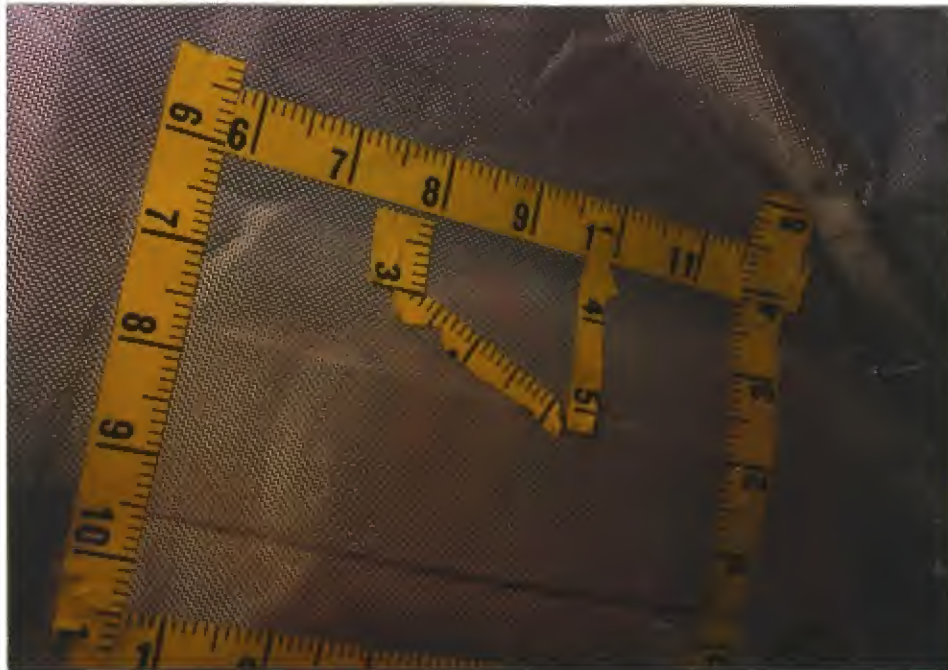
21

Close-up View of Driver's Facial Contact, Lipstick and Makeup Transfers

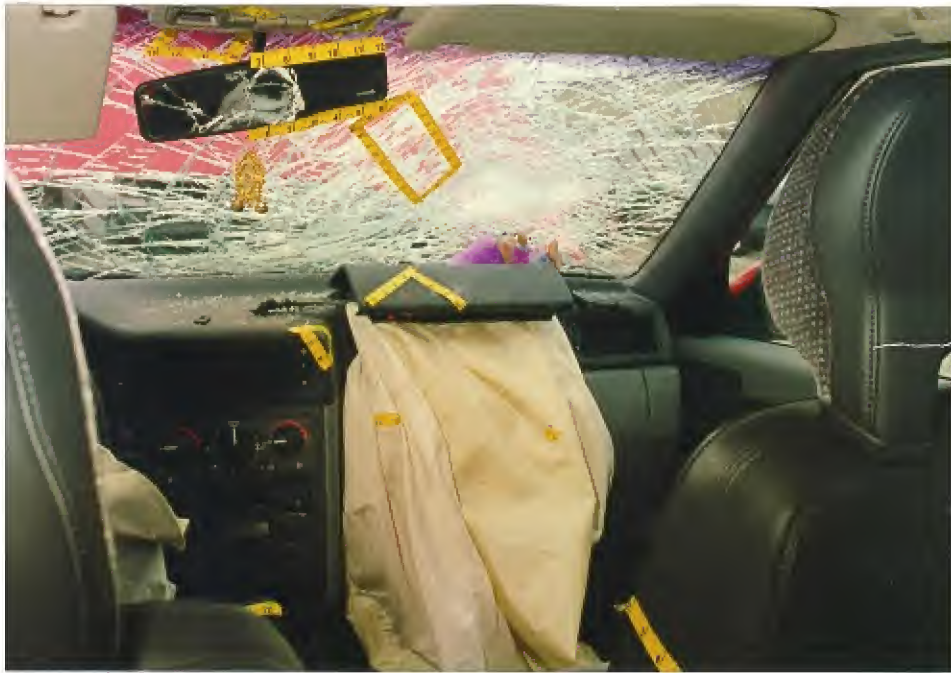
27

Trajectory and Subsequent Contact Points of the Child Passenger

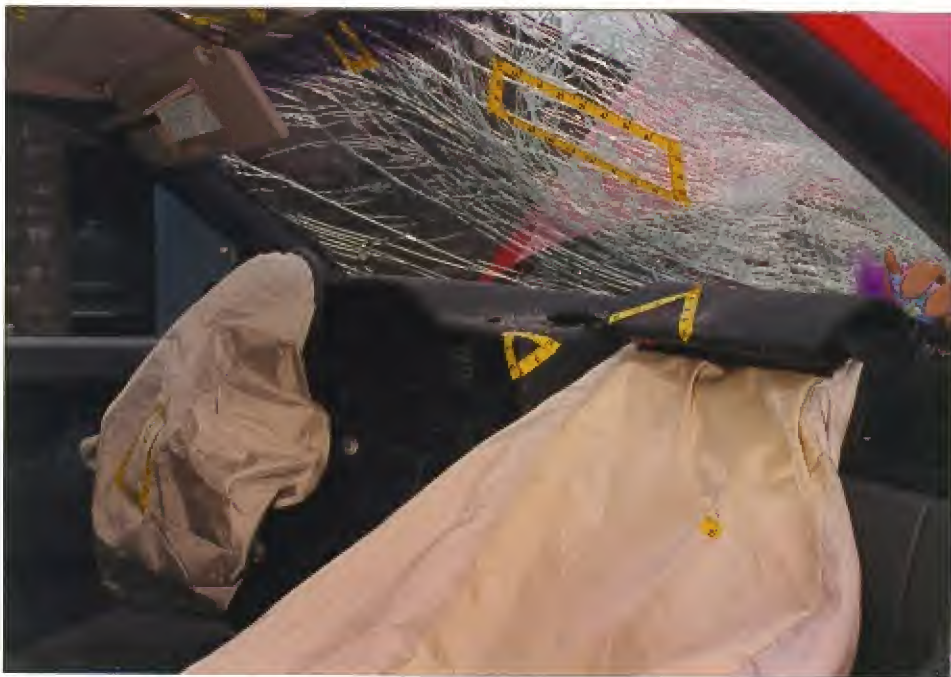
28

Right Front Passenger Air Bag Module Cover Flap and Deployed Air Bag

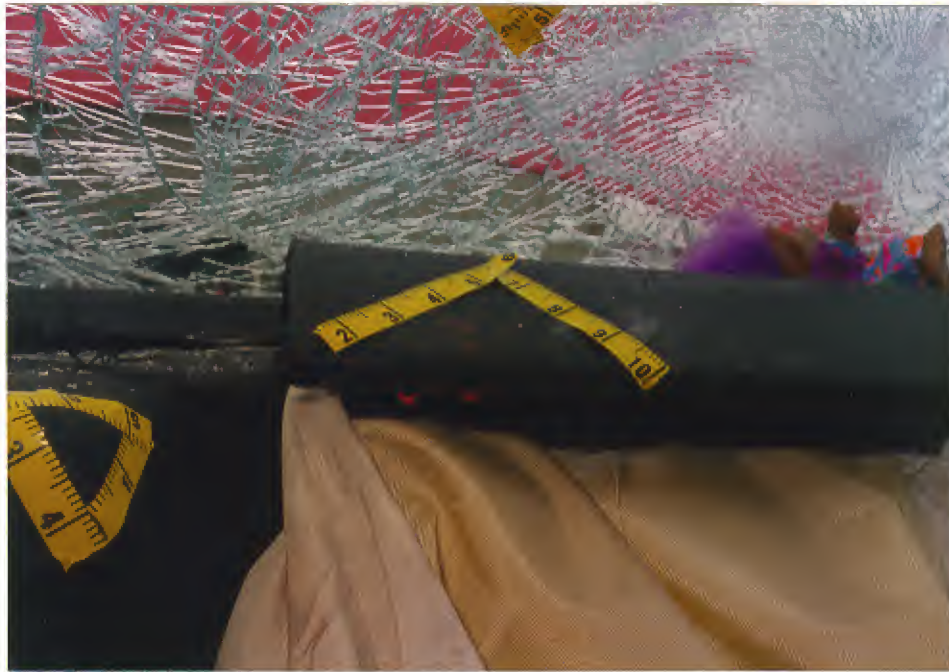
29

Fabric Transfer Extends 2" Vertically Onto Face of Module Cover Flap

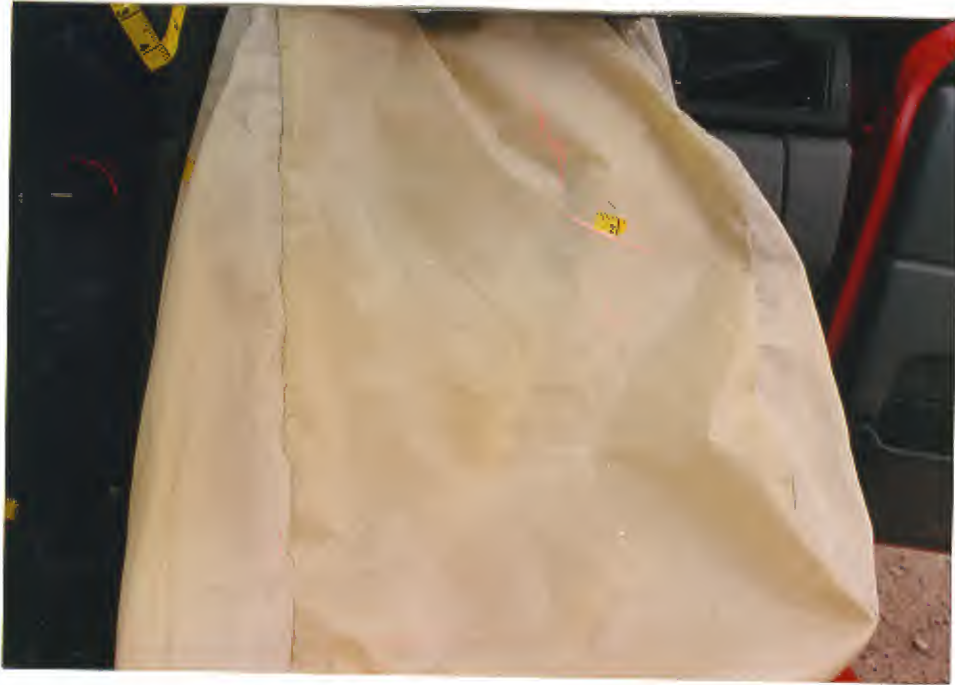
31

There was a small 9.5 mm (0.4") diagonally orientated tear at the top surface of the passenger bag. The tear was located 28 cm (11") from the module and 12.7 cm (5.0") inboard of the lower right seam. The edges of the tear appeared to be discolored (darkened), similar to exposure to heat or the hot gases venting through the tear. There was no other damage or occupant contact evidence to the passenger air bag.

Passenger Side Air Bag

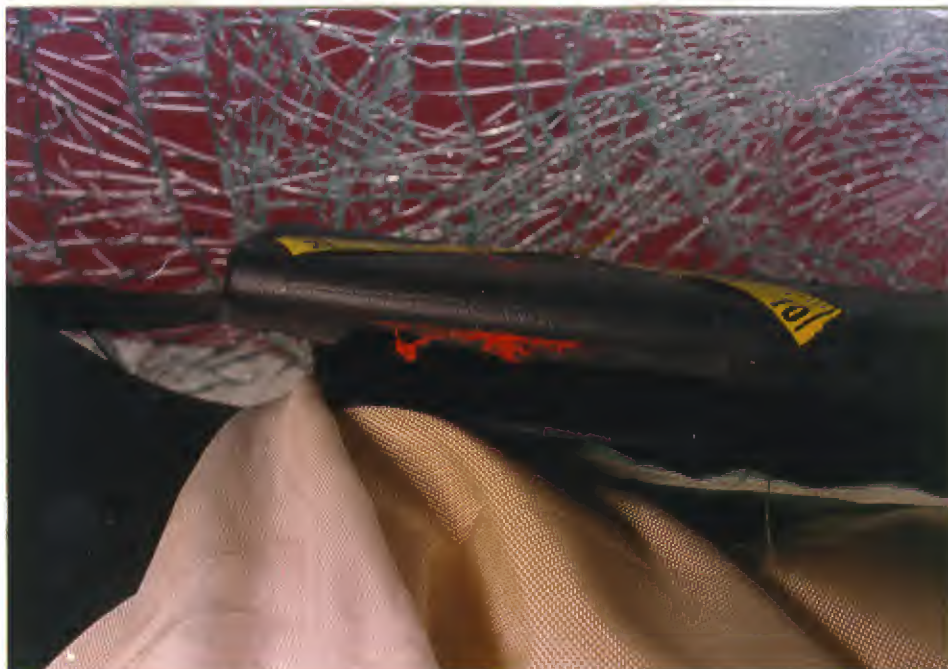
32

Orange Fabric Transfer on the Leading Edge of the Passenger Air Bag Module Cover Flap that Resulted from Contact with the Child Passenger's Jacket

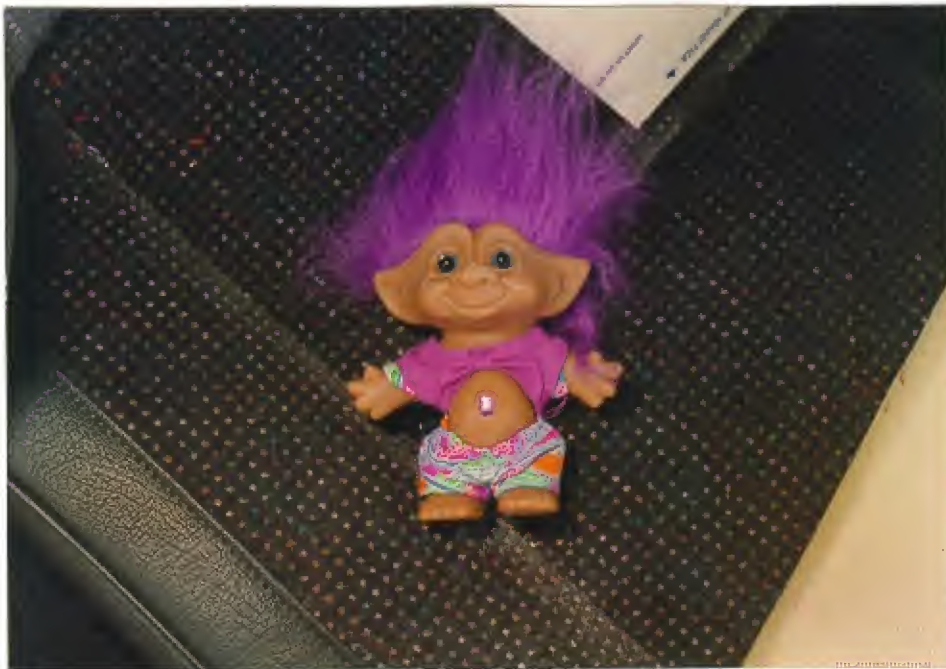
46

Glass Abrasion to the Face of the Troll Doll

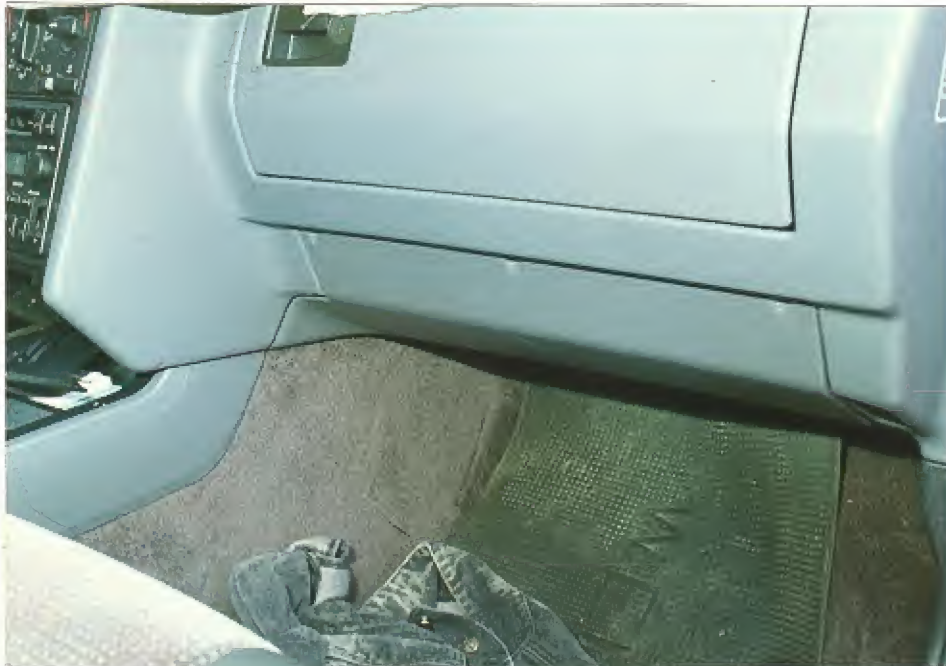
47

Child Passenger Came to Rest on Right Front Floor
with Head Resting on Right Front Seat Cushion

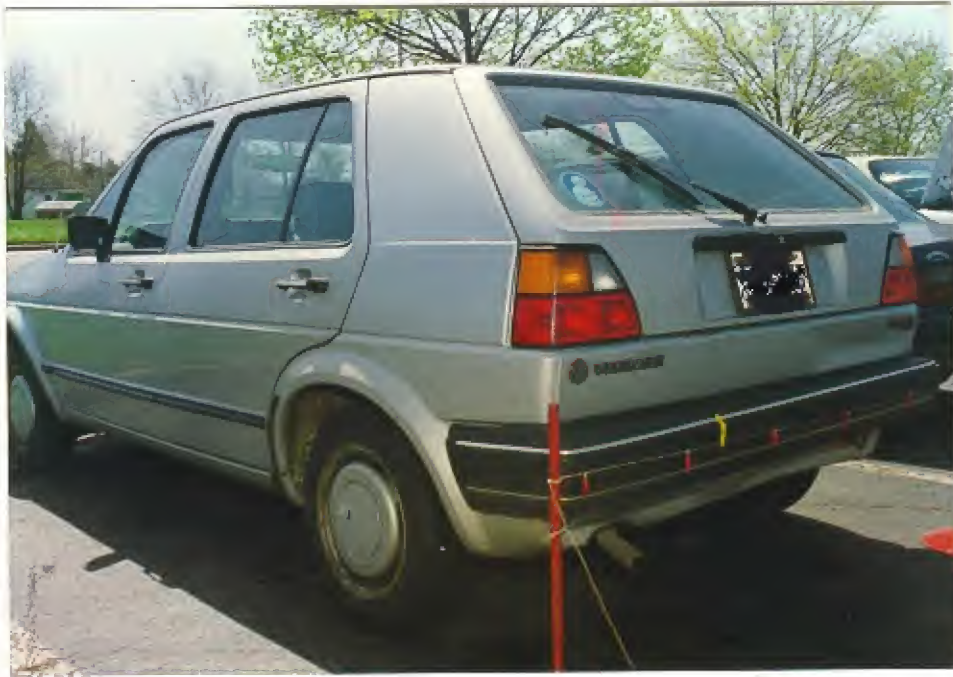
52

Direct Contact Damage Begins 12.25" Left of Center
and Extends 41.4" to the Right Rear Bumper Corner

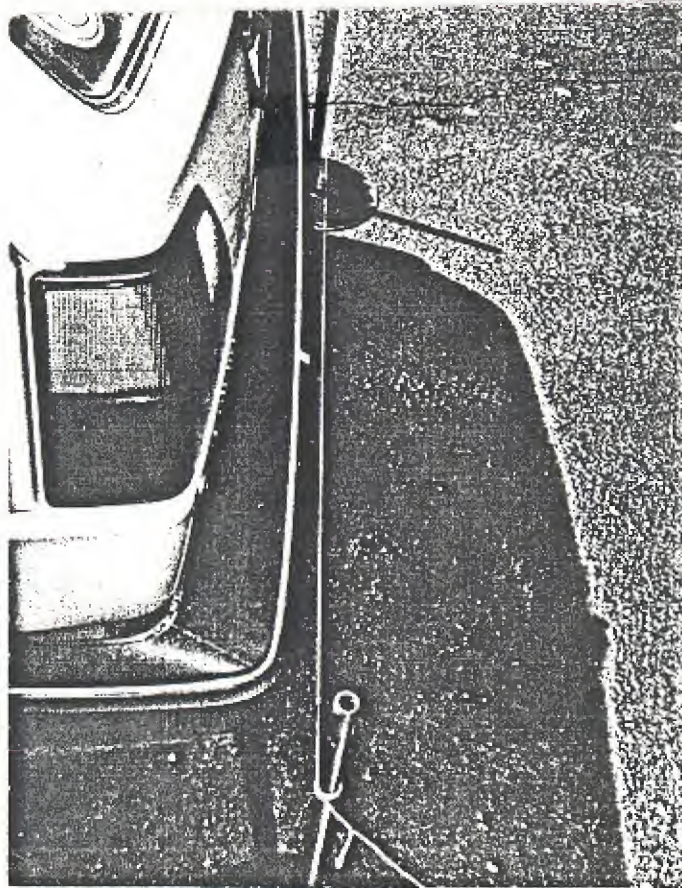
53

Left Rear Three-Quarter View

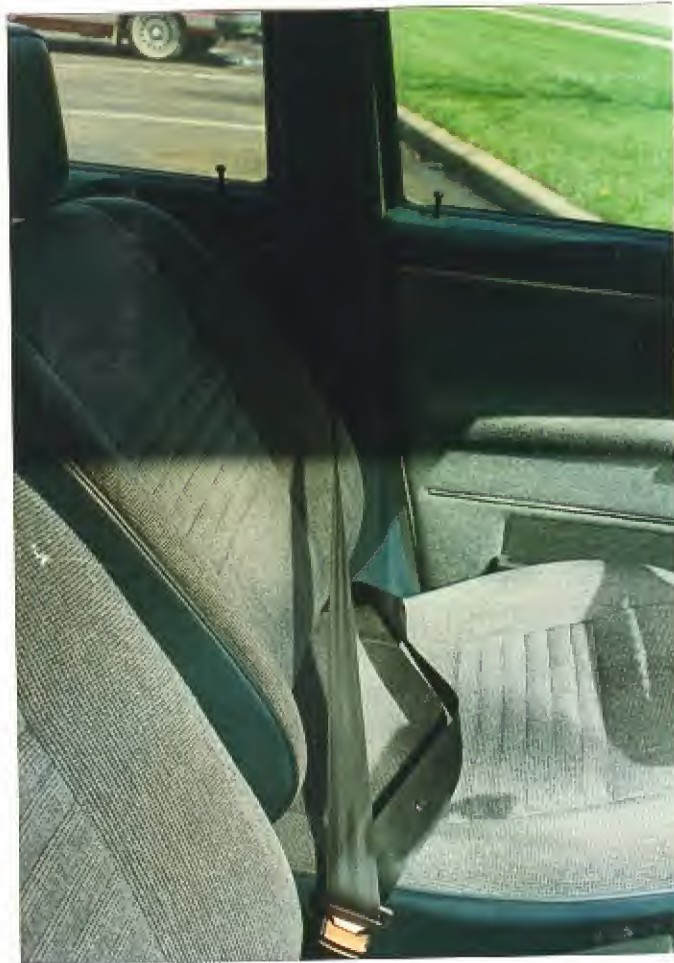
56

Overall View of the Driver's Seated Area
